STATEMENT OF SIGNIFICANCE

St Peter & All Hallows, West Huntspill

DIOCESE OF BATH AND WELLS

The church is listed **grade I** and in the district of Sedgemoor

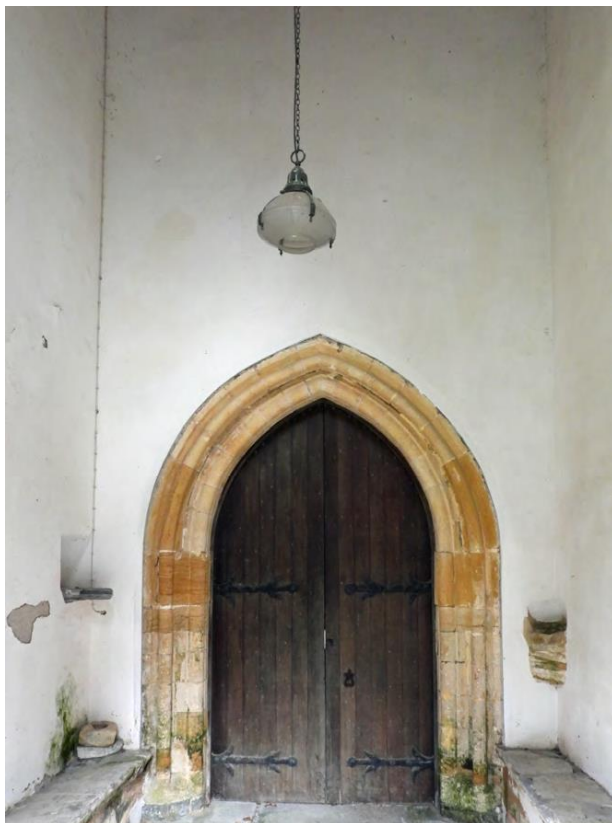
The South Porch

In the South Porch is the one item believed to have been from the original Church of the 12th century: a defaced stoup. It is on the north east angle of the porch and would have been used by Parishioners entering the Church in the later Middle Ages. Beneath the bowl is a corbel stone which is relatively well preserved, probably carved from Dundry stone.

The south nave doorway shows early English architecture. This part of the building consists of an ostensibly 14th or early 15th Century doorway with continuous roll-mouldings and a mixed geology. The leadwork on the south porch roof includes graffiti which predates the 1878 fire and the south porch appears to have been entirely unaffected by the fire.

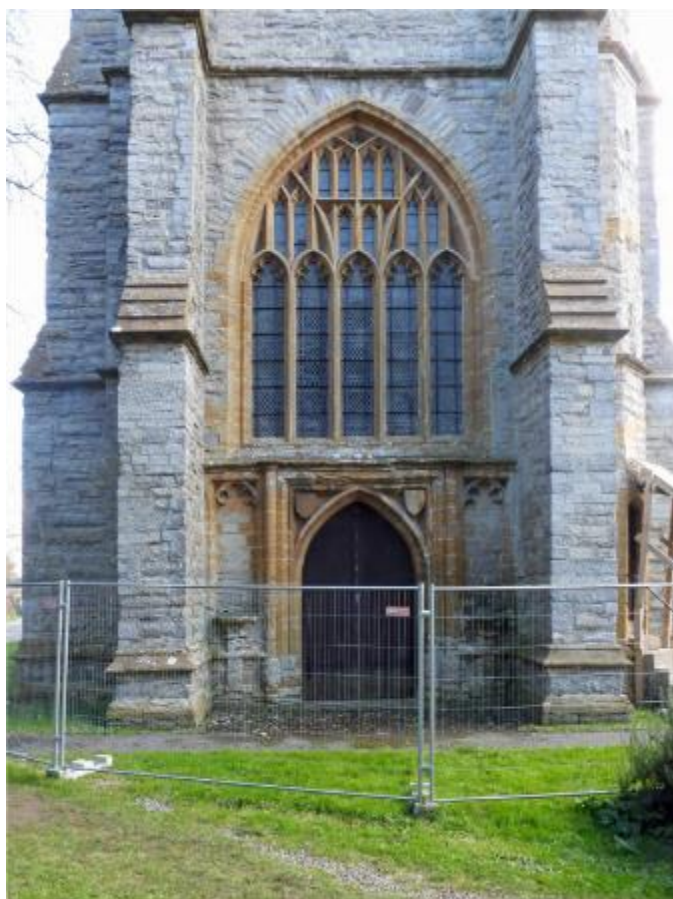
West entrance of the Tower

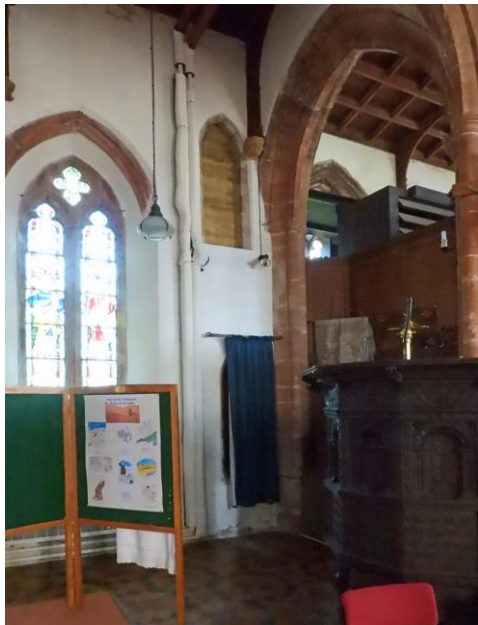
In St Peter & All Hallows the stairway giving access to the rood-loft was on the north side of the east nave bay (as the picture below shows). There does not appear to be any fire-reddening of the ashlar surrounding the upper doorway, suggesting that this may have been blocked and plastered over at the time of the fire. On the exterior there is a projecting demi-hexagonal turret which partly incorporates the diagonal buttress at the north-west corner of the chancel aisle, rising to terminate in its own parapet (as the picture below shows).

The blocked-up entrance to the Rood-Screen

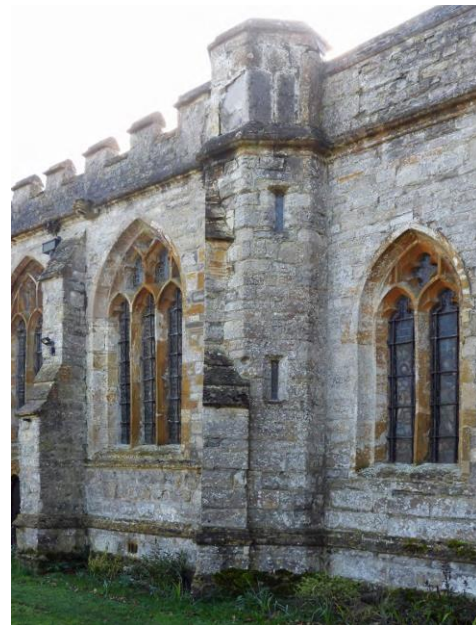
Demi-hexagonal turret, this would have been the stairway to the Rood-Screen

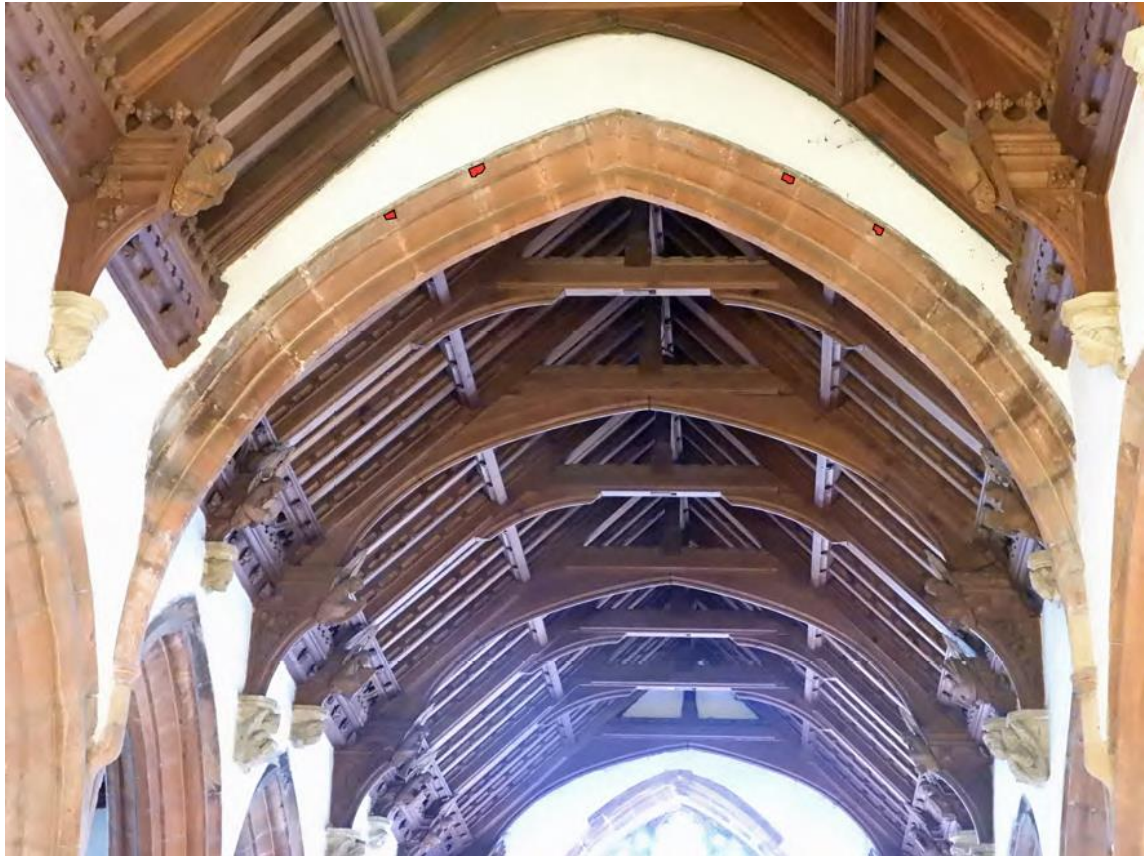
Today both the Chancel and Nave have head-stops and corbels for ashlar posts supporting the roof as the picture above shows. This collection of head-stops, some medieval, combined with Victorian roof and the medieval open arcades are considered to be the most important architectural elements in defining the character of the interior of the Church.

The watercolour sketch of the church interior subsequent to the fire shows only the chancel being provided with head-stops and corbels for ashlar posts supporting the roof, the nave wall-heads being plain surfaces.

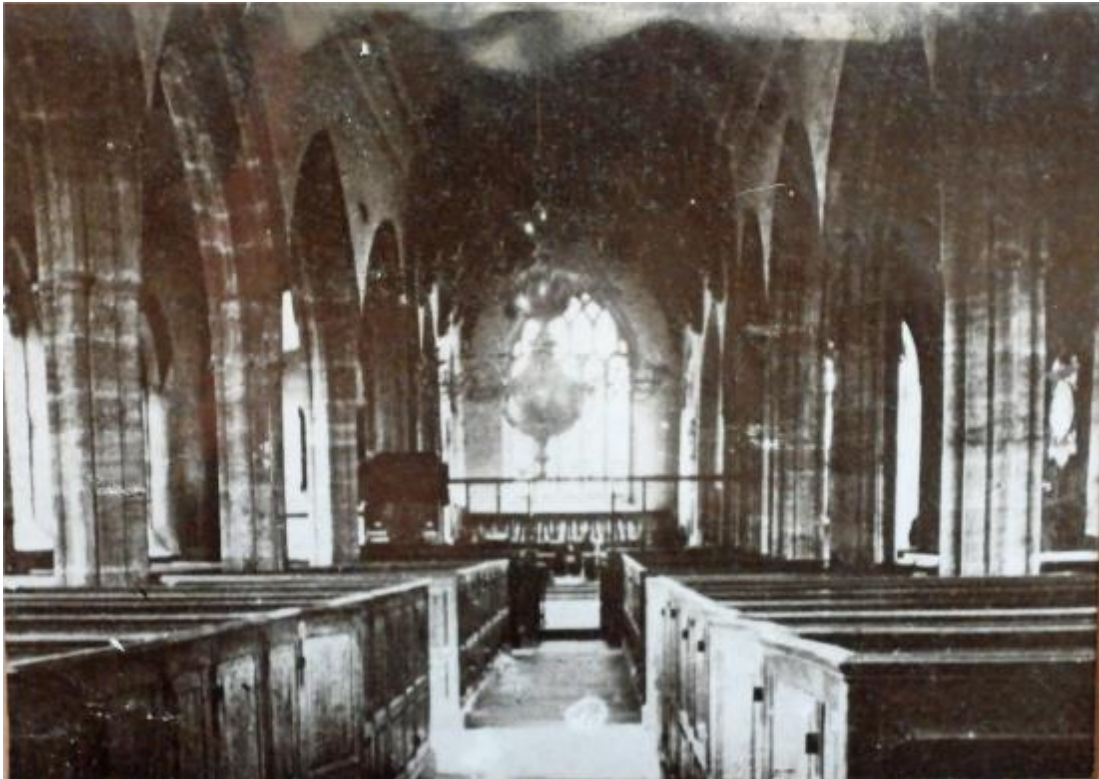
PICTURE OF CHURCH BEFORE THE FIRE

Below is a photograph of the interior of the Church before the 1878 fire, taken from the west end, there are no other records of the contents of the Church that were lost in the fire.

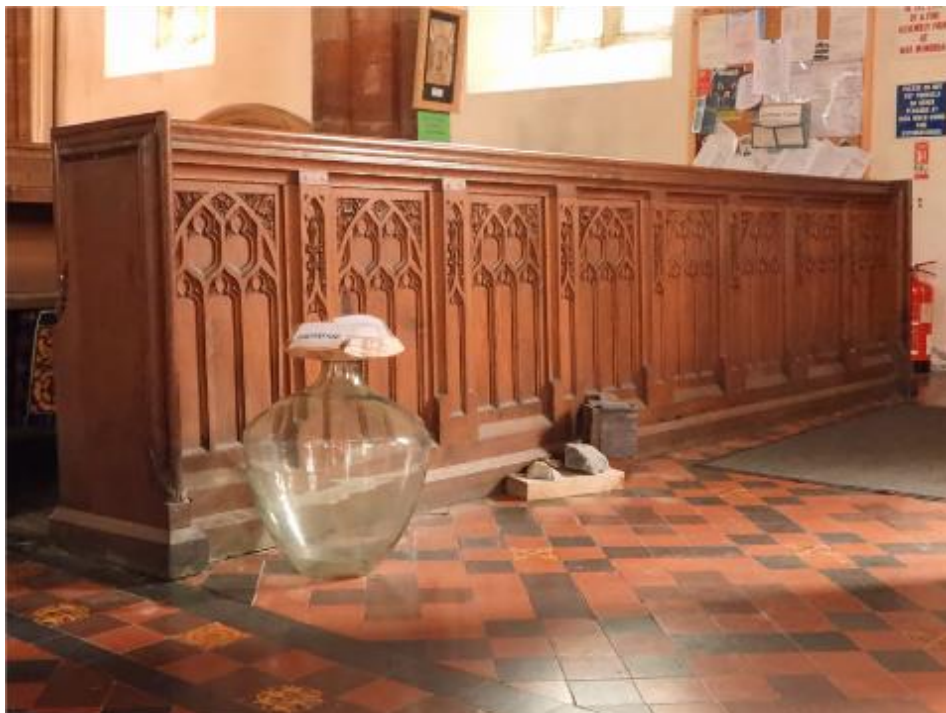
Their ends have a single standard design: a plain central ground with a moulded edge running out at just above floor level (west) and just above the seat (east) with a foliate triangle. In typical Victorian fashion several ends are made up from two blocks joined vertically. Their backs are panelled, the rectangular sunk panels being framed with vertical muntins and moulded top rails. No assembly or location marks were identified, and accessories, such as hat-pegs, umbrella holders etc. appear to be absent. There are traces of what appear to be a lighting system in the form of holes drilled through the bookrests, these would appear to relate to the heating and lighting system identified by Mr John Lamb (details on page 11) No other elements such as place-holders, seat numbering or designated free-seats were not identified in the survey.

The back of the pews at the eastern side of the cross aisle

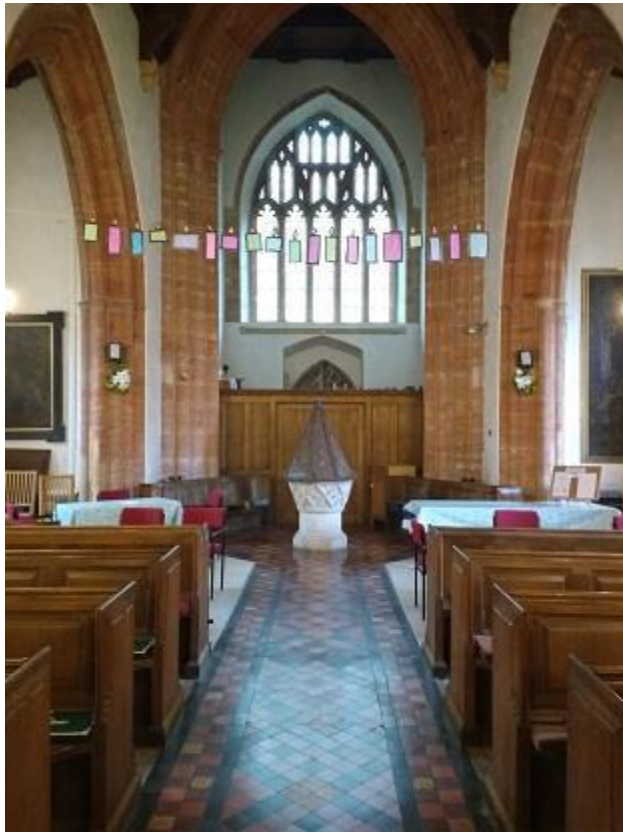
At present in the base of the Tower (behind the oak screen) is a not-fit-for-purpose kitchen, whilst the rest of the area is used for storage, which is not well organised. Putting toilets and purpose-built facilities for cleaning materials & the flower arrangers will enhance this area. Access to the west door will still be maintained. The entrance to the belfry, ringing chamber and top of the Tower are all from an external staircase.

An oak screen divides the base of the Tower from the main body of the Church. We have explored different screen positions and we now propose to adapt the existing oak screen by retaining and bringing forward the doors thus giving enough space for the toilets and storage in the base of the Tower.

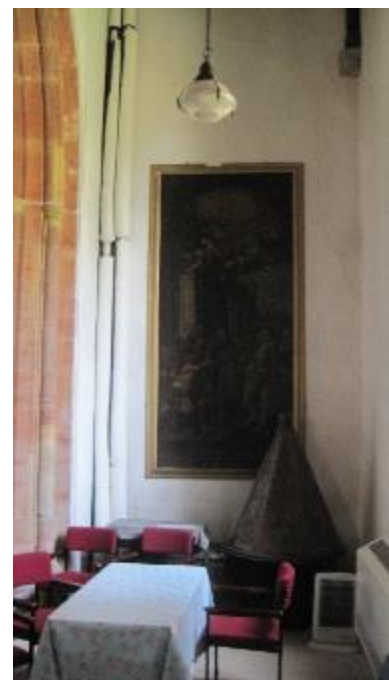
OAK SCREEN

FONT (shown in the picture for the Oak Screen)

We are mitigating the impact by retaining the oak screen and moving it forward rather than replacing it with a new screen. (Following consultation with the Church Buildings Council and the SPAB, the proposal is now to replace the screen)

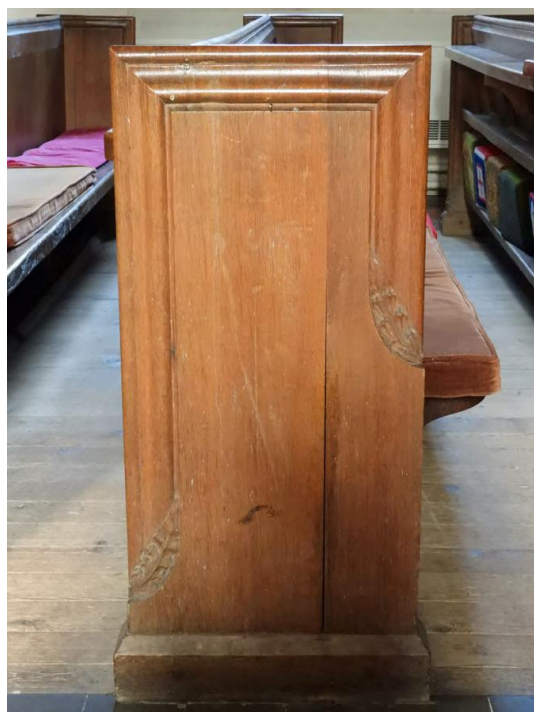
PEWS

Jerry Sampson carried out an Archaeological Assessment of St Peter & All Hallows Church in March 2020 and this is his survey on the pews: -

Clearly the existing benches do not pre-date the 1878 fire (though one possibly introduced bench may have been added to the corpus). The benches occupy the eastern section of the aisles and nave, being separated by the east-west gangways and the cross-aisle gangway between the nave doorways. Their ends have a single standard design: a plain central ground with a moulded edge running out at just above floor level (west) and just above the seat (east) with a foliate triangle. In typical Victorian fashion several ends are made up from two blocks joined vertically. Their backs are panelled, the rectangular sunk panels being framed with vertical muntins and moulded top rails. No assembly or

location marks were identified, and accessories, such as hat-pegs, umbrella holders etc. appear to be absent. There are traces of what appear to be a lighting system in the form of holes drilled through the book-rests, these would appear to relate to the heating and
